# Level One Report

0328-The Waters, Ooralea Stage 7

5676/P/25-1

Prepared for Vassallo Constructions Pty Ltd  
15/09/2025

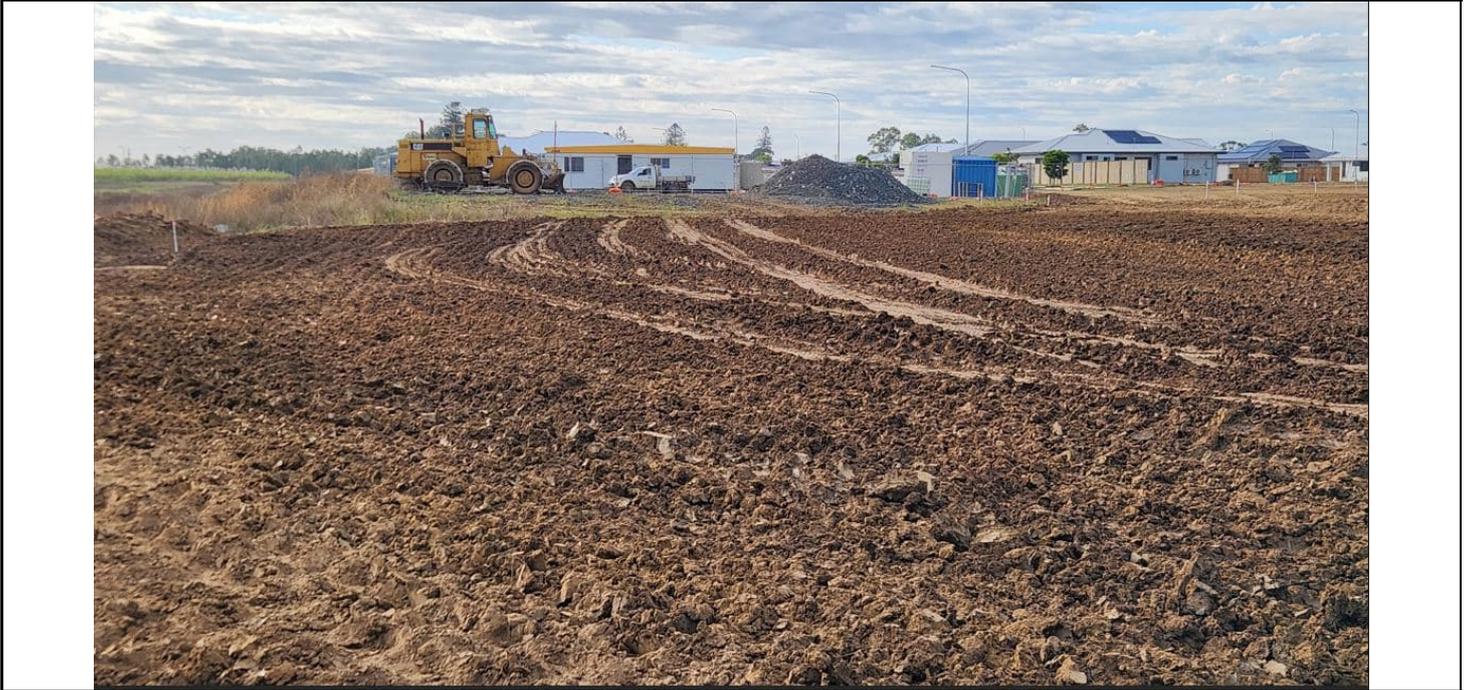
Image Description: Proof roll 1 Failed area

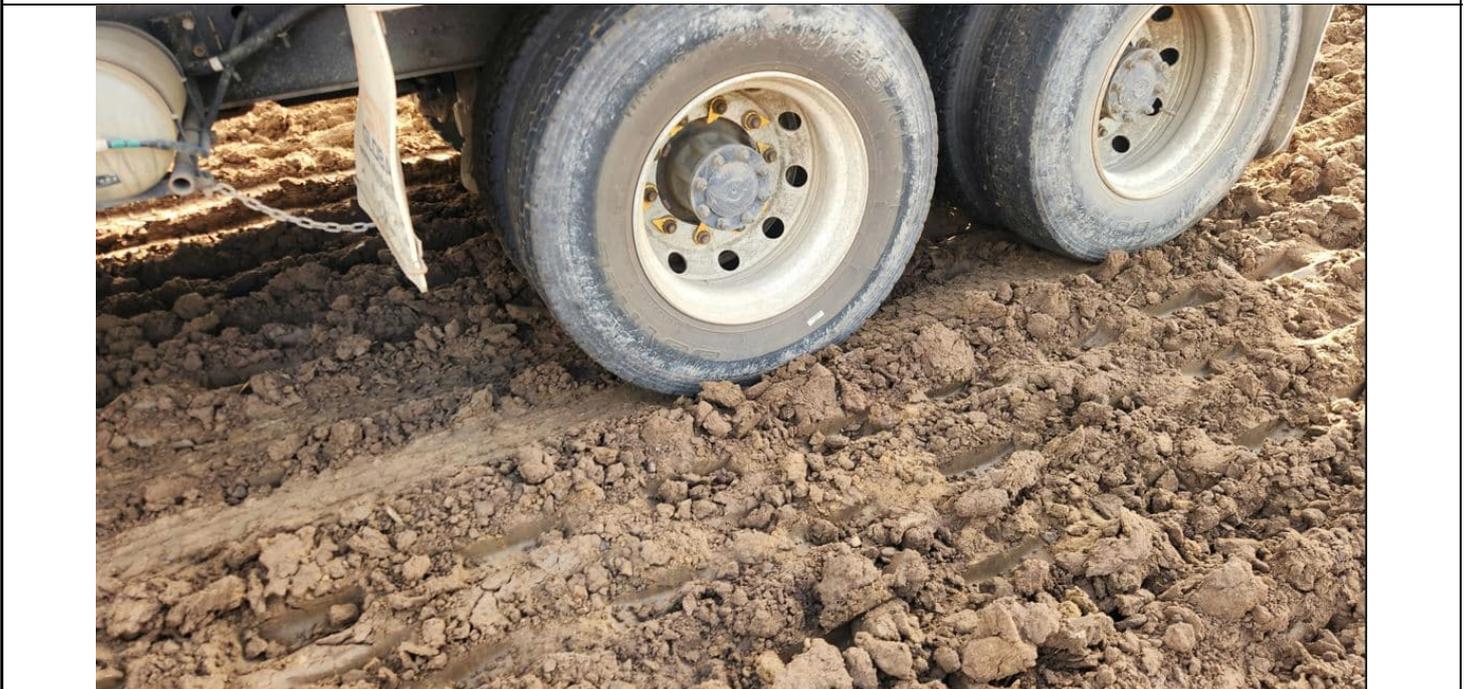
Image Description: Proof roll 2 Failed area

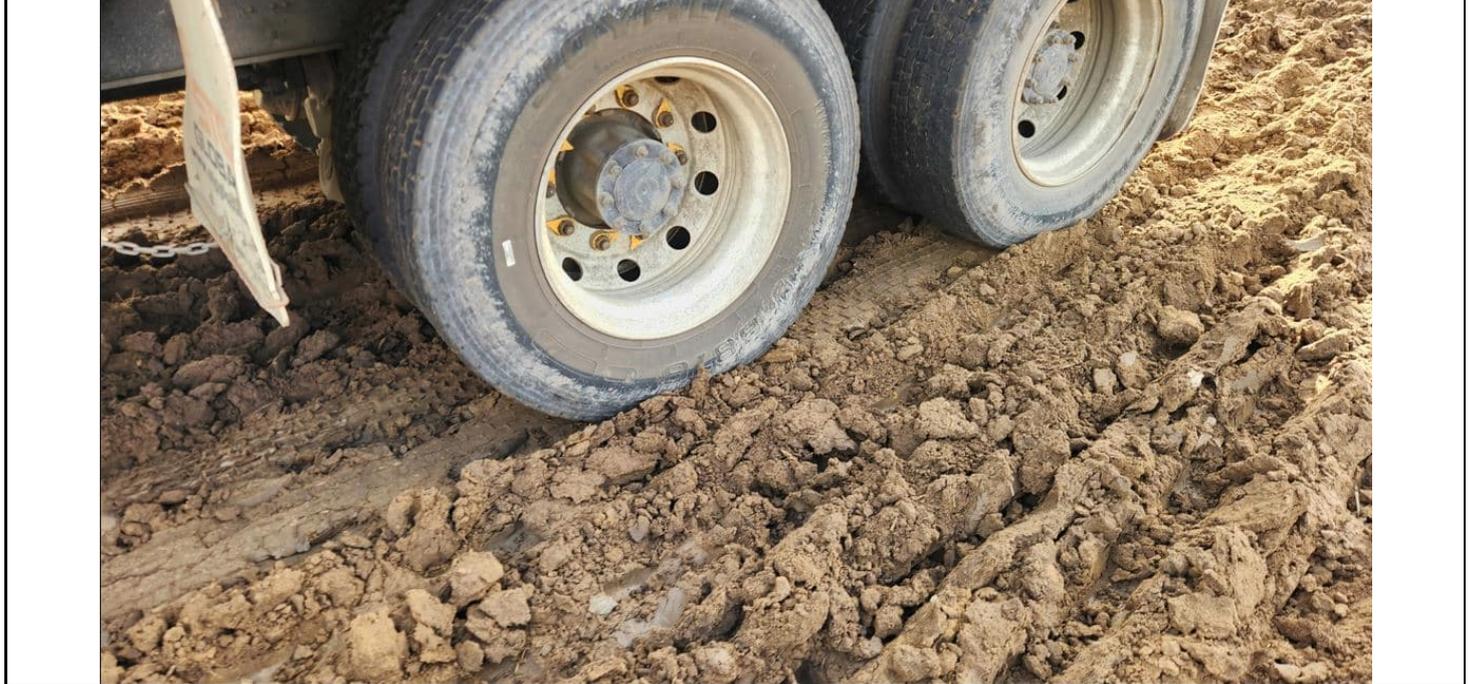
Image Description: Proof roll 3 Failed area

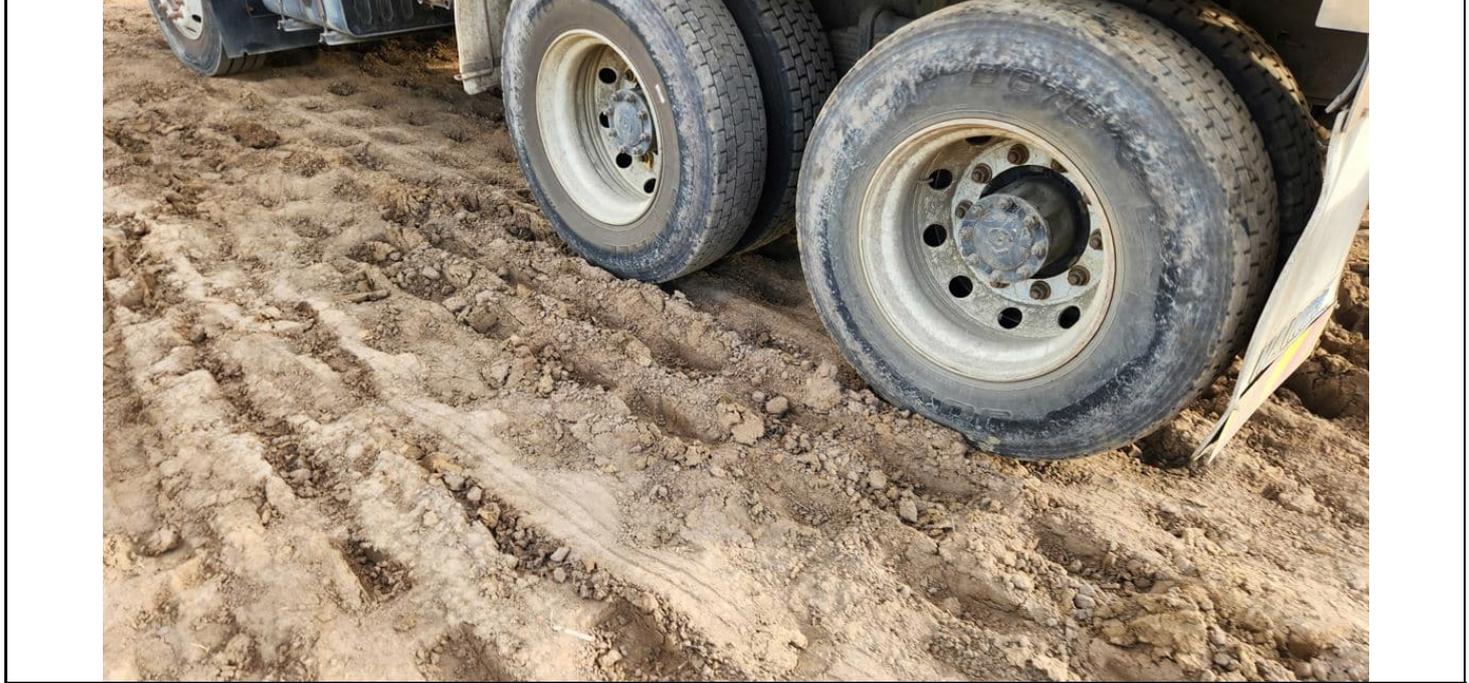
Image Description: Proof roll 4 Passed area

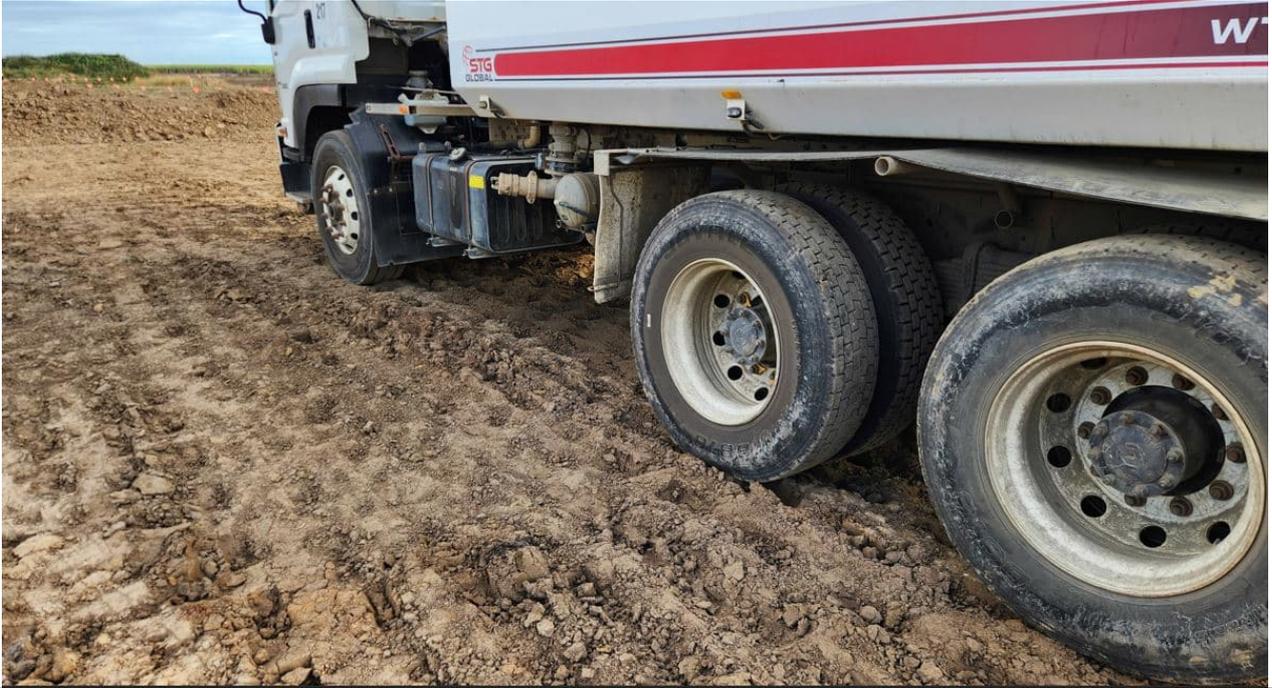
Image Description: Proof roll Passed area

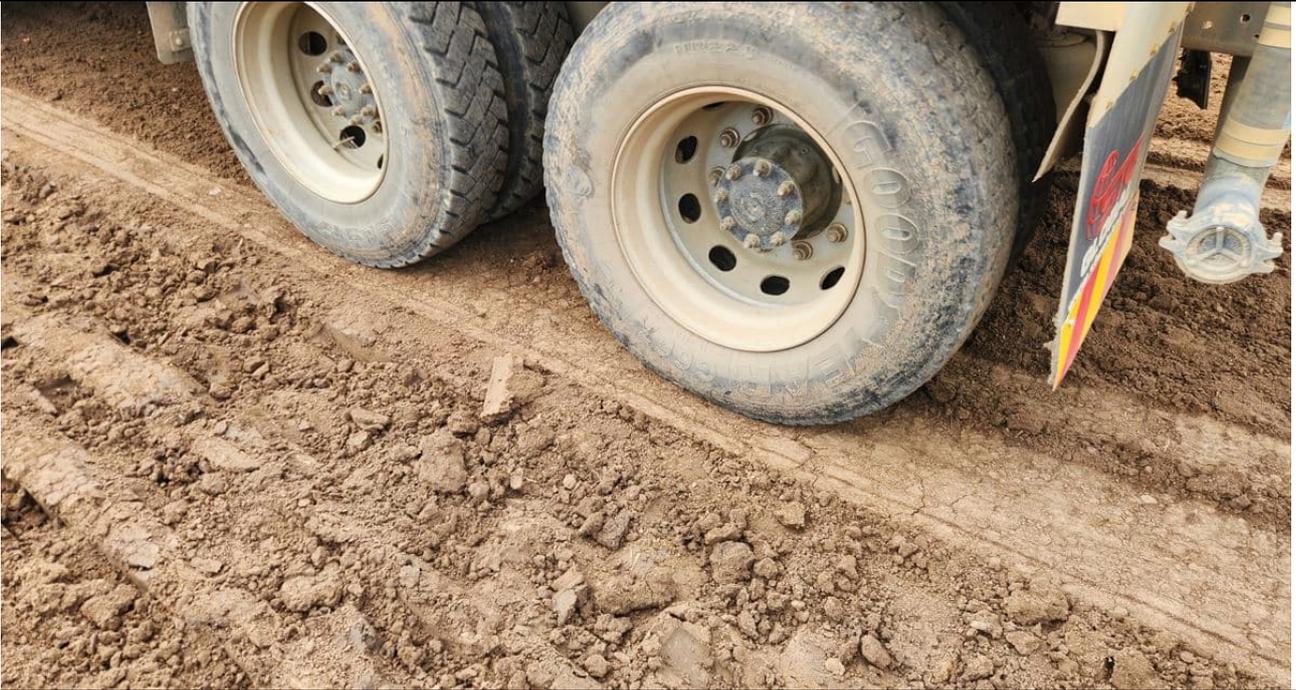
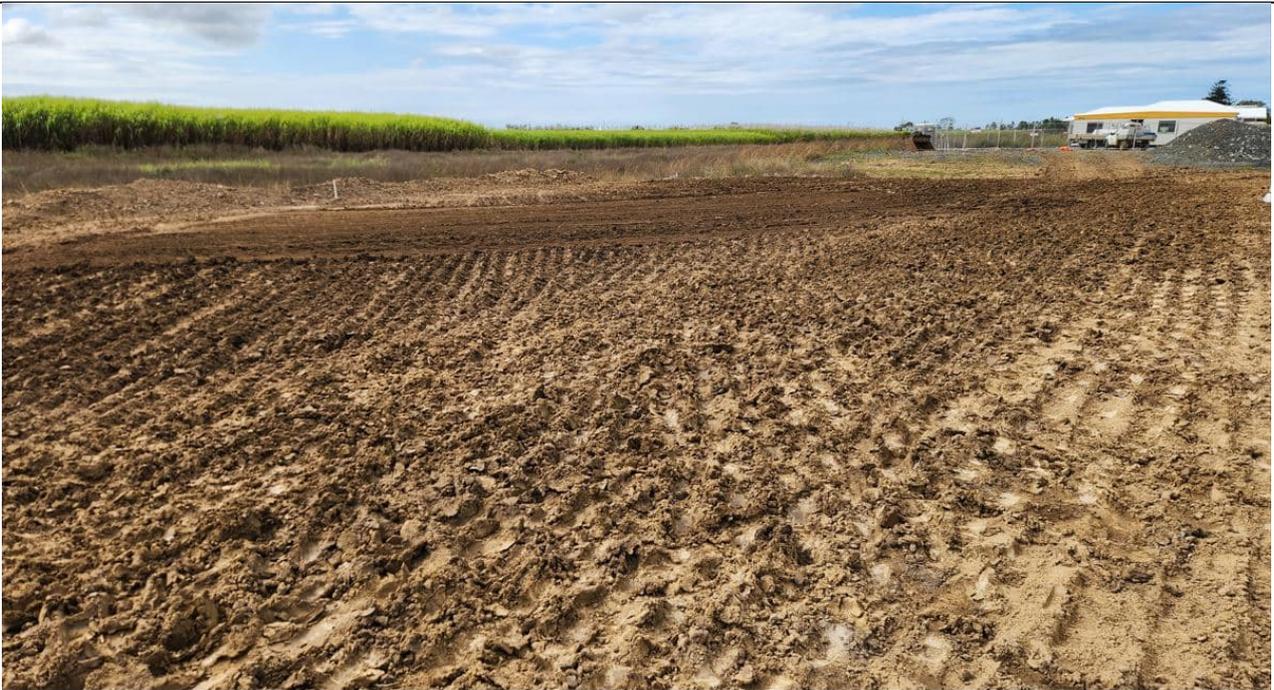
Image Description: Proof roll (2nd) Lot 745 - 747

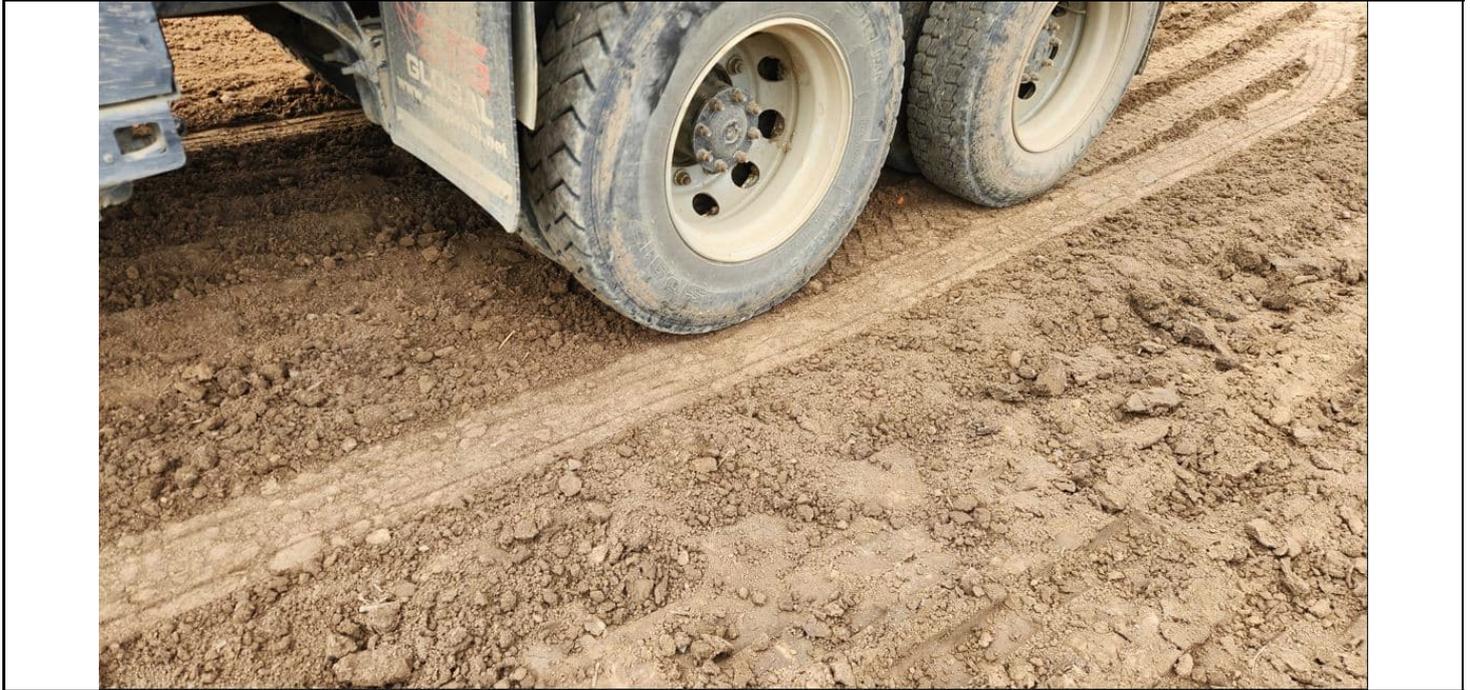
Image Description: Proof roll (2nd) Lot 745 - 747
