# Level One Report

0328-The Waters, Ooralea Stage 7

5676/P/25-1

Prepared for Vassallo Constructions Pty Ltd  
15/09/2025

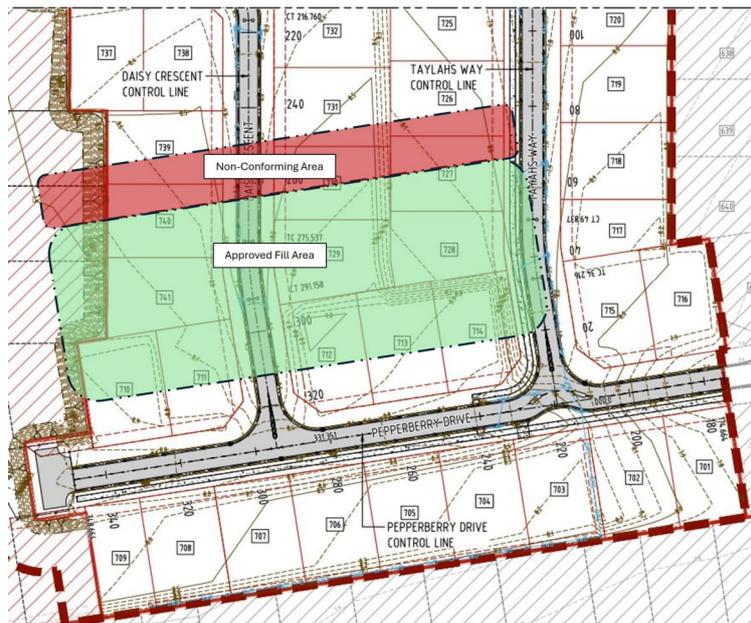
Proposed Fill Area

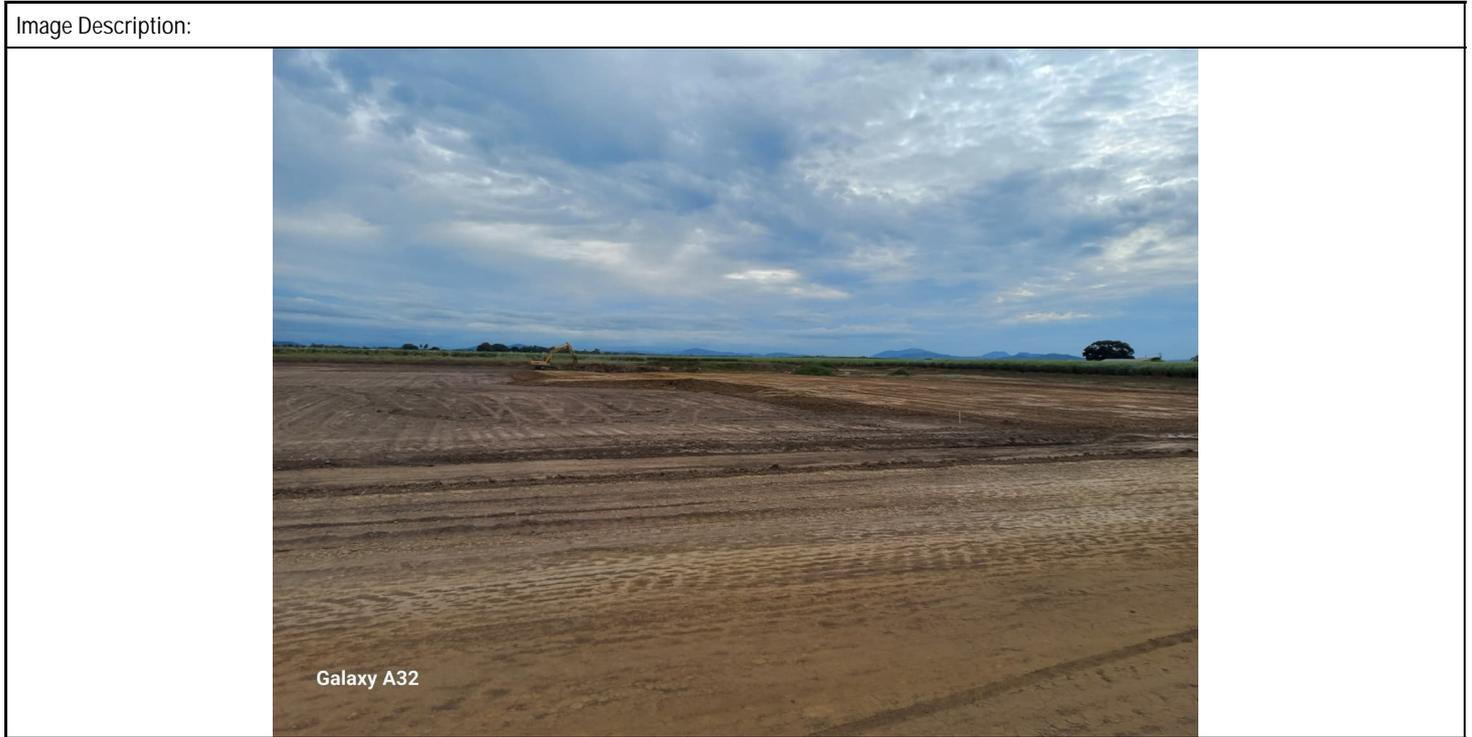
Works failing to meet geotechnical requirements	Element:	Refer to work type (e.g., stripping, subgrade compaction), basis of assessment (e.g., inspection, test reference numbers, and the like), extent of work apparently failing to comply, requirements not met, action taken (instructions issued, retests ordered, and the like).
	Result:	Unsuitable material in Section 5 is being removed down to the underlying brown sandy clay.

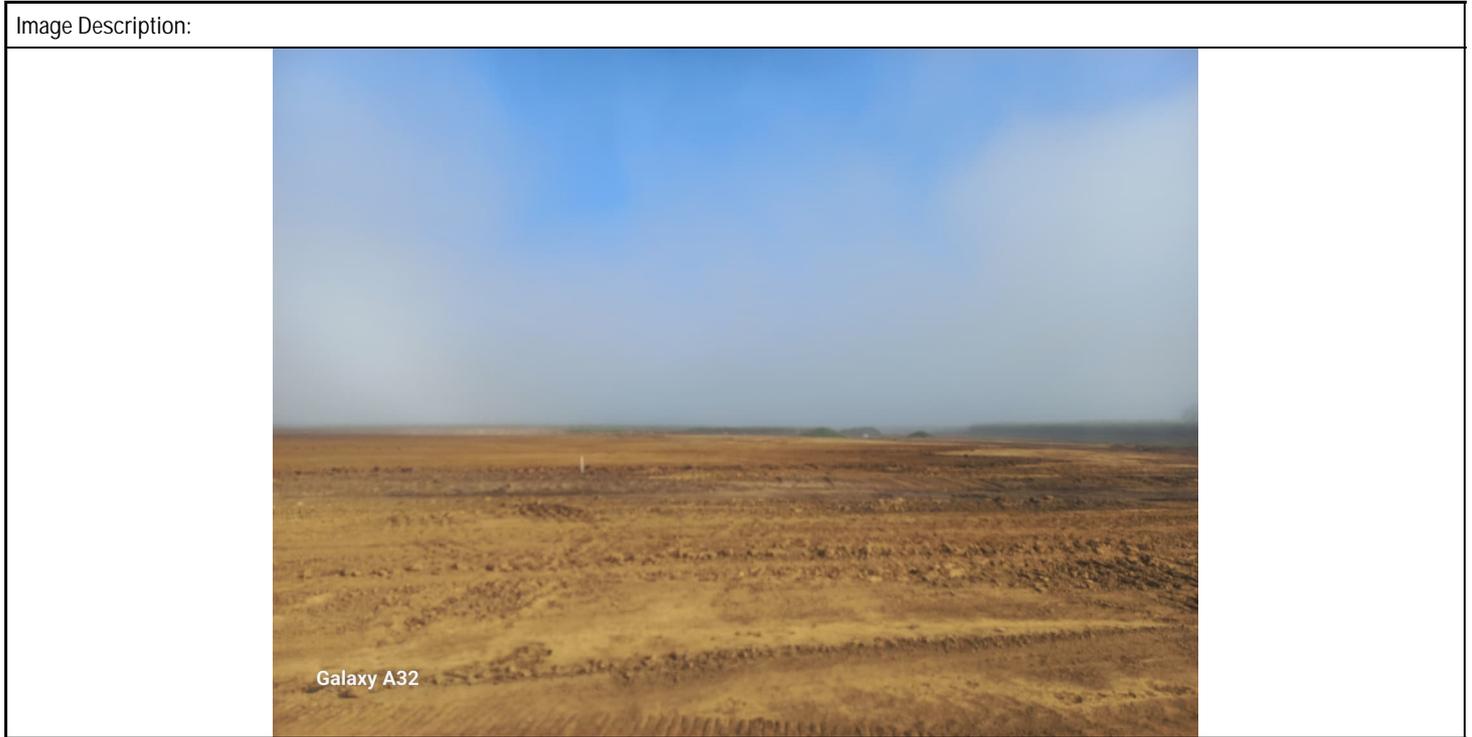
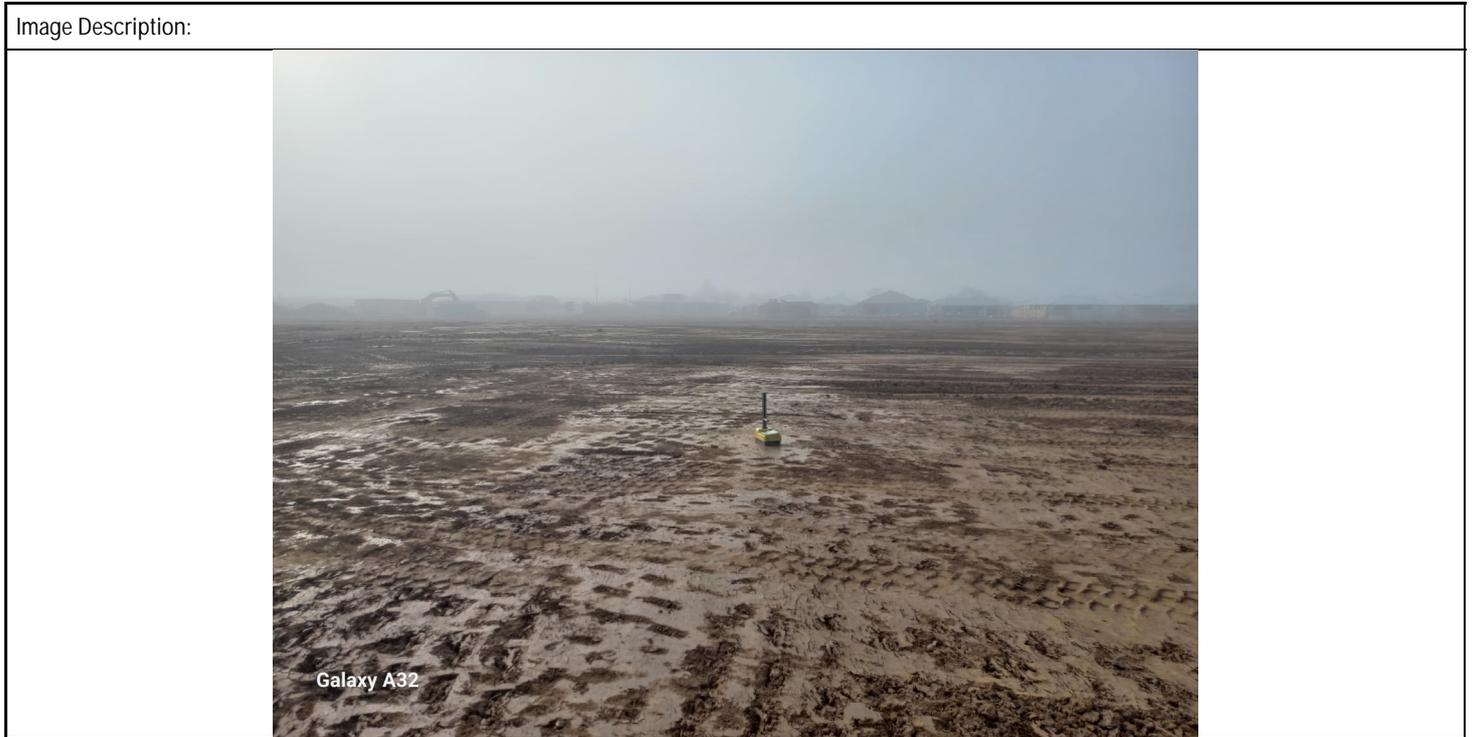
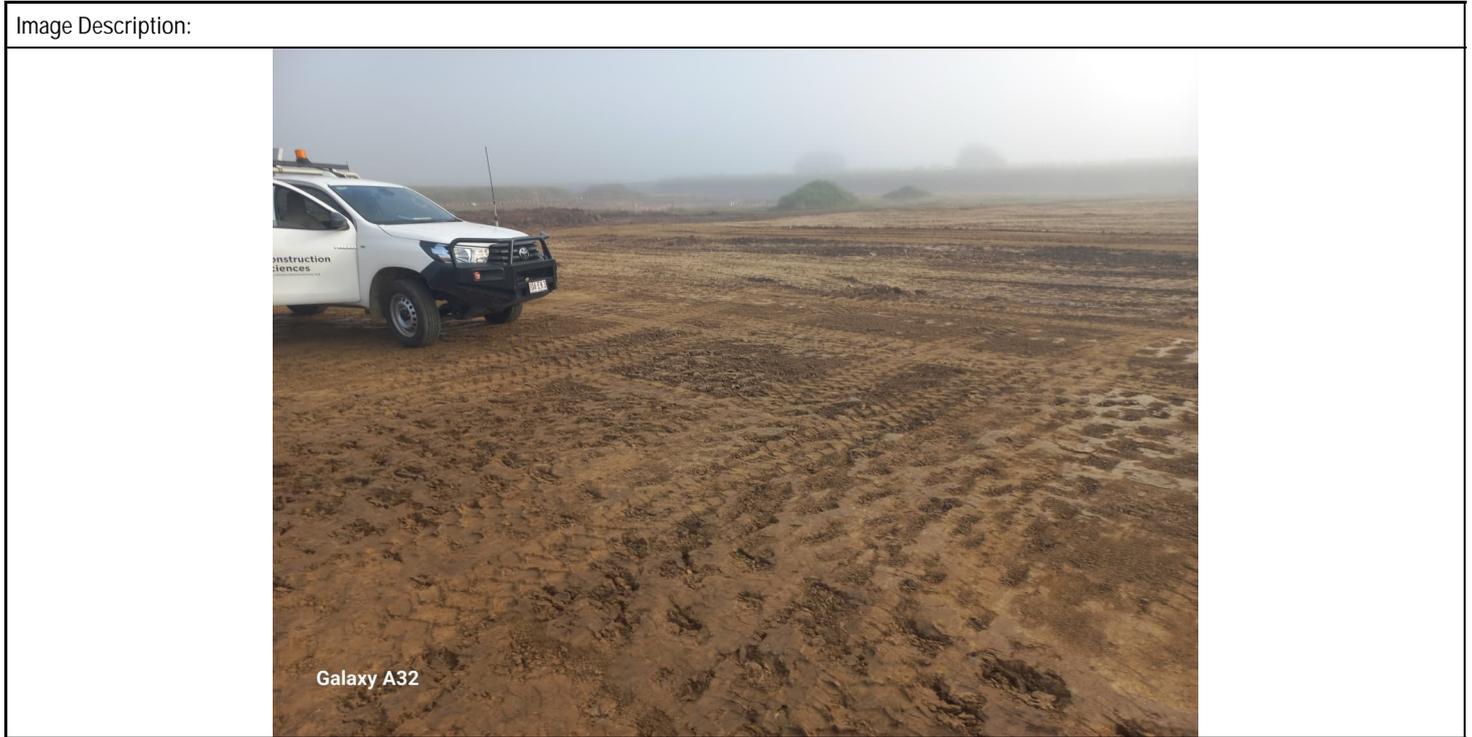
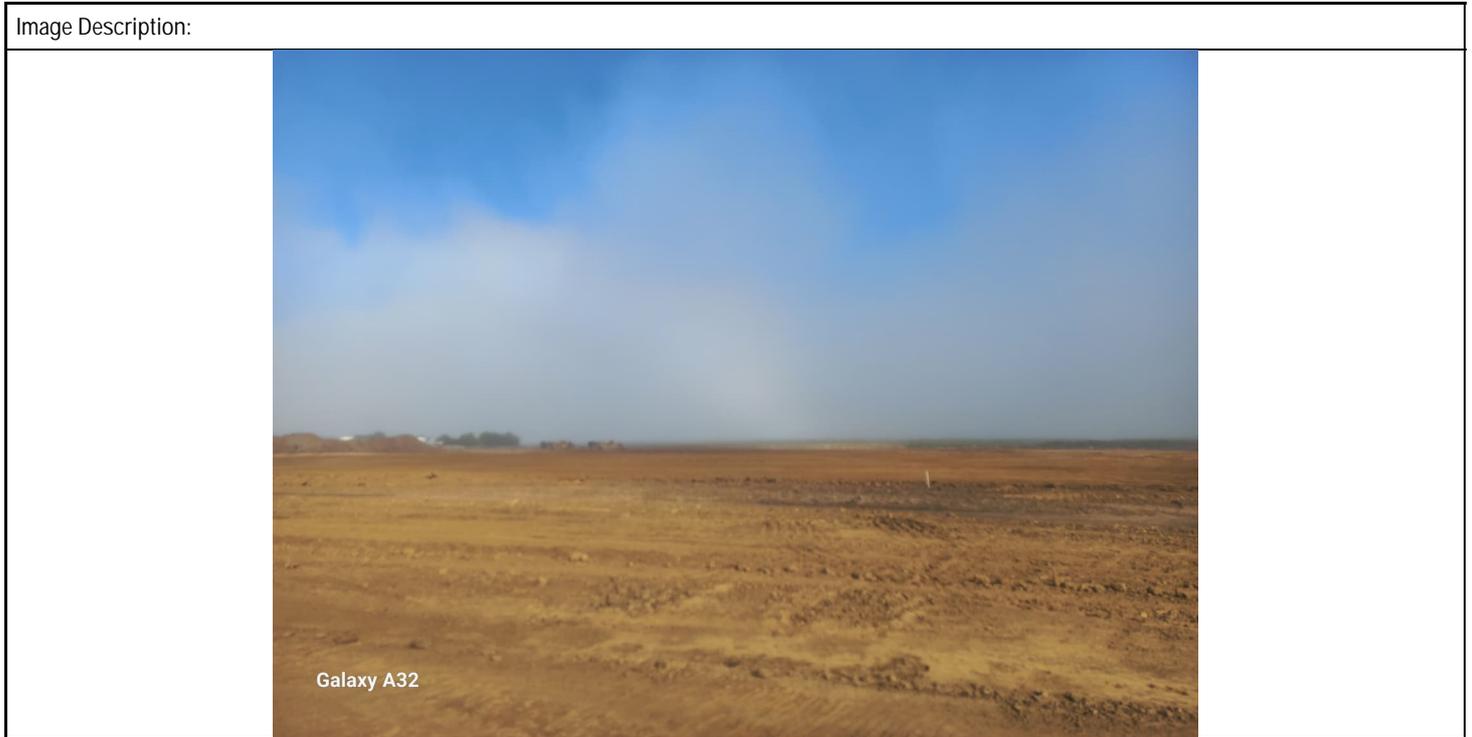
Result:	Lots 745-747 Failed the proof roll, having areas of deflection in the area.	
Remarks	Element:	Include observations on works, site conditions, meetings or conversations on site, and the like.	
	Result:	Client informed to re-work the failed area, before conducting another proof roll in the area. Lots 742-744 were passing the proof roll test.

Corrective Action Required? Yes	Re-Inspection Date: 23/07/2025
	Corrective Action Details: Proof roll the former failed area, Lots 745 - 747.
